7th Battalion Royal Scots

Quintinshill 22 May 1915

Robin Nelson

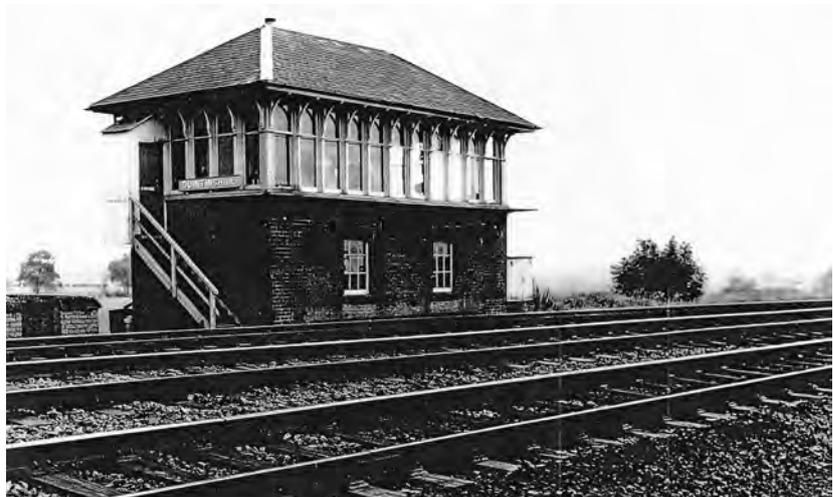
A view of the site of the crash can be had from the overbridge about a mile to the north. It's a rural scene and, apart from the overhead electric wires, little seems to have changed over the intervening one hundred years. But there has been one change of significance. The signal box with the name of Quintinshill has gone. It was a signal box of importance controlling the movements of passenger and goods trains on this busy line with down and up loops available to allow faster trains to pass slower moving traffic.

Quintinshill signal box was commissioned in 1903 and lasted until 1973 when electrification and re-signalling of the WCML resulted in the power box at Carlisle taking over control of the line.

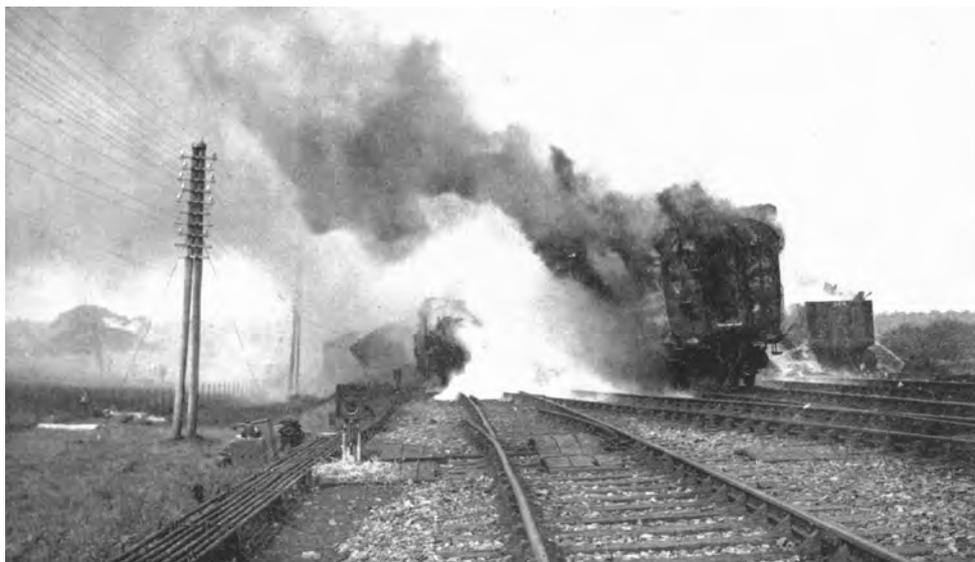
Contemporary press photograph

The conflagration at Quintinshill on 22 May 1915 following the collision of the south-bound troop train with the stationary local passenger train which had been shunted on to the up main line to be in turn hit by the Glasgow sleeping-car train. Two hundred and twenty-seven people died, most of them servicemen bound for Gallipoli.

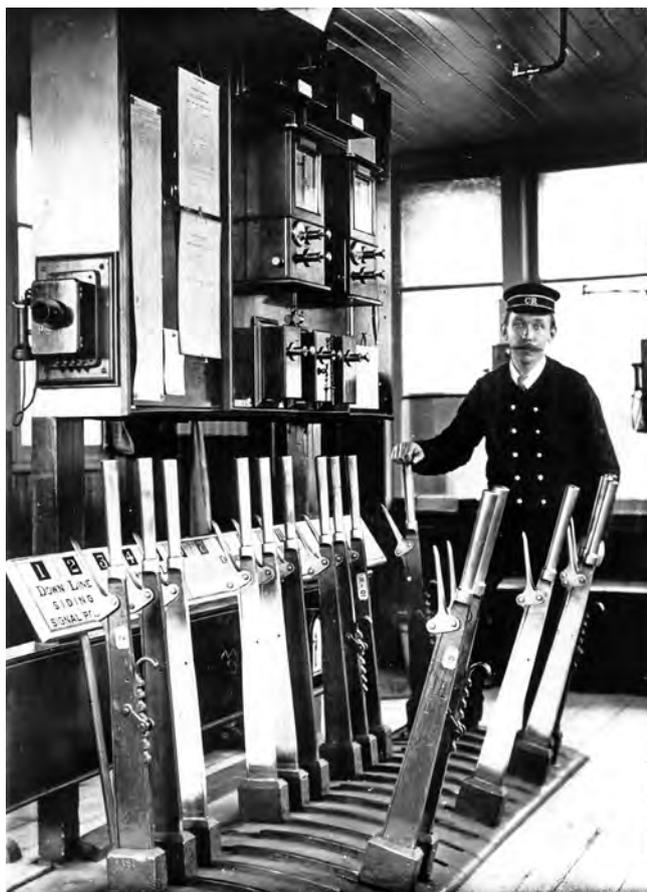
A Caledonian signal box equipped with Tyer's block instruments. The lower plunger is operated to send 'line clear' to the neighbouring signal box. The upper plunger is operated when the neighbouring signal box sends the bell code for 'train entering section'. The glass panel above the plungers protects two miniature semaphore arms which operate in conjunction with plunger operation. Sending line clear causes the bottom arm in the sending instrument and the upper arm in the receiving instrument to lower. Acknowledging 'train entering section' by the upper plunger restores both miniature semaphore arms to the horizontal position.

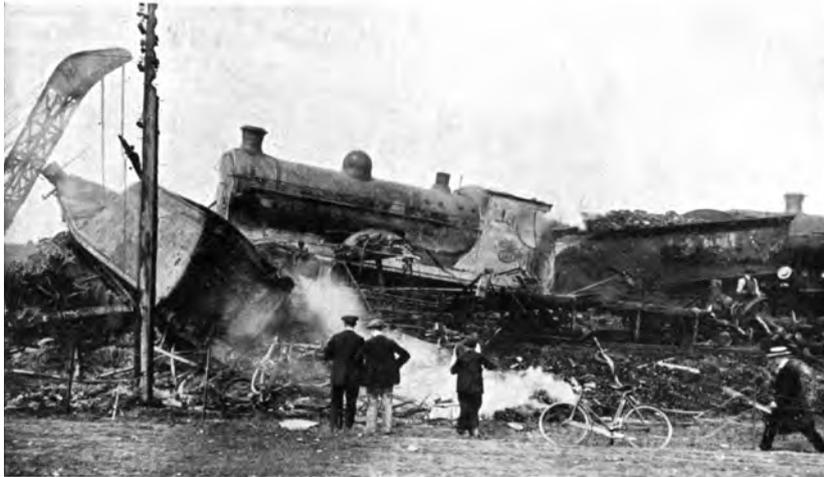
The locomotives of the double-headed sleeper train on top of the wreckage of the troop train.

but both signalmen were too stunned to react. At 6.50 am, the two locomotives of the sleeper hit the wreckage of the troop train, rode up and over the carriages of the troop train.

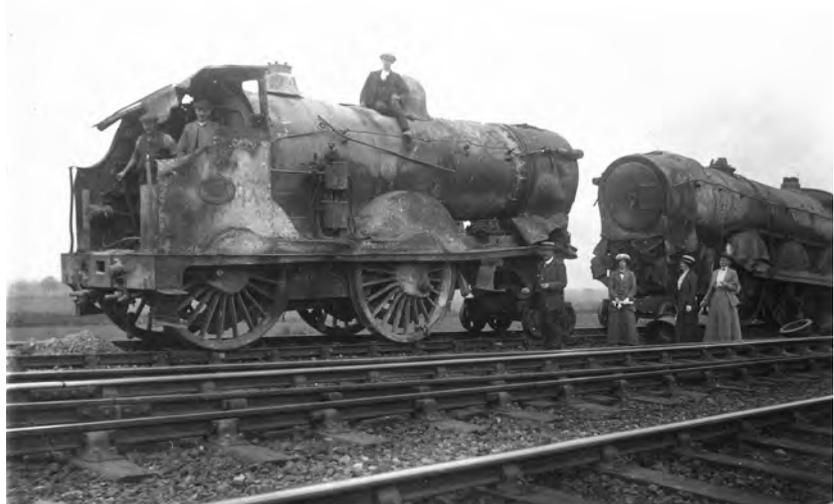
The two locomotives involved in the head-on collision: Caledonian Railway 4-4-0 No 121 and CR 4-6-0 No 907.

At 6.48 am, the troop train appeared travelling at 60mph and collided with the locomotive of the stationary passenger. Dreadful, but worse was to follow. The Glasgow sleeper had passed Gretna at speed. There was time to throw the down line signals to danger

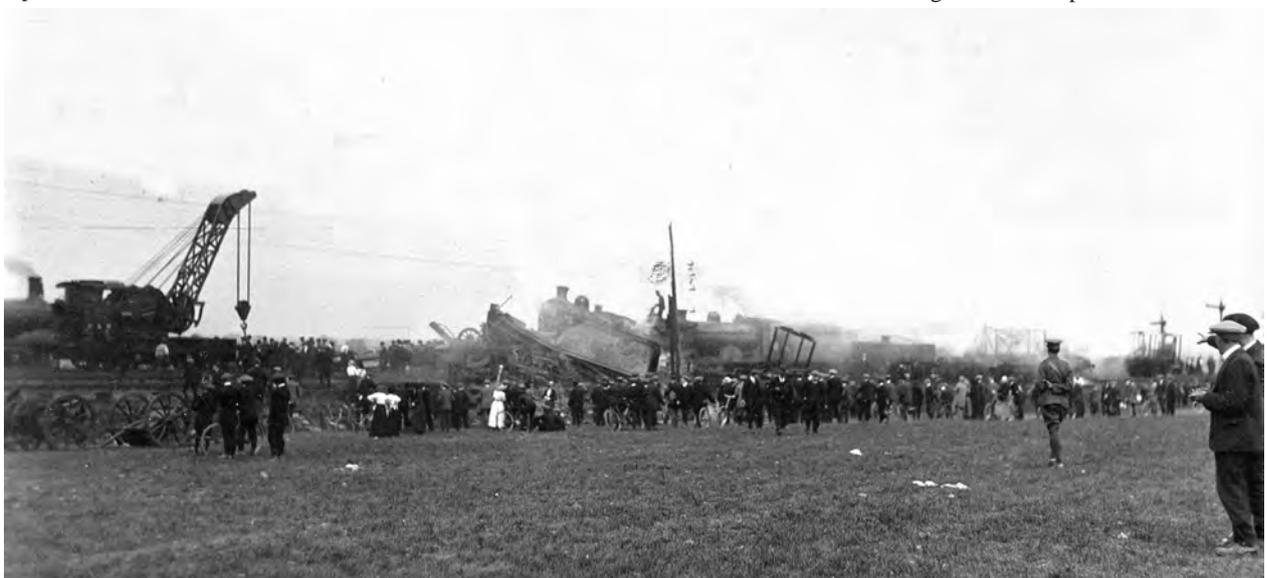
The process of clearing up the mess attracted much attention from the public.

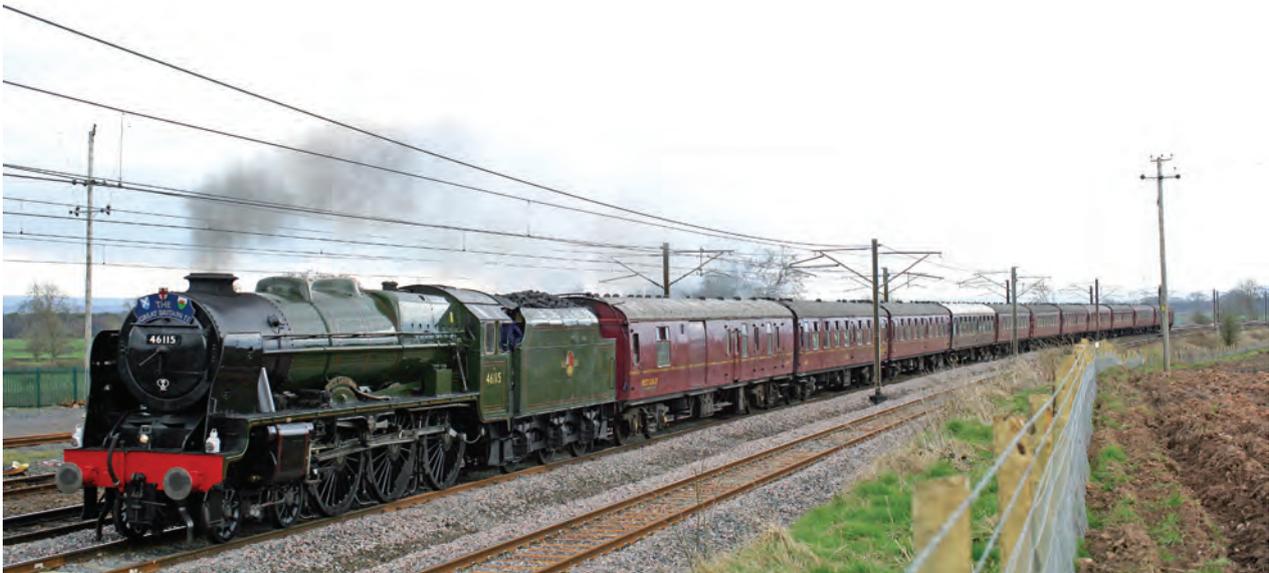
On 9 April 2009 'Royal Scot' No 46115 Scots Guardsman was working the down 'The Great Britain II' from Preston to Glasgow at Quintinshill where the layout is much the same except the crossover has been repositioned and is only used occasionally. Dave Hall
